T. Harris Environmental Management Inc.  
*Environmental Consultants*

931 Commissioners Rd East,  
Suite 100  
London, Ontario N5Z 3H9  
Tel. (519) 685-9048  
Fax. (519) 685-1084  
**1-888-ASK-THEM**

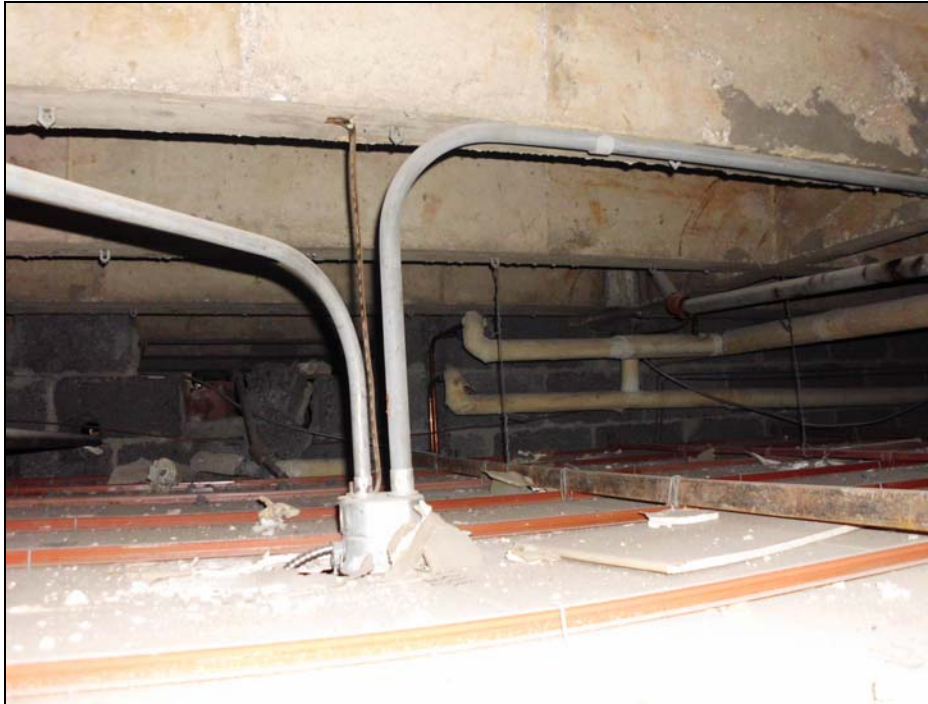
Photograph 1: Asbestos-containing linear pipe insulation and pipe fittings above the suspended solid ceiling in Room 1.31 – Girls Washroom. Pipe fittings identified as Priority 1's were repaired in 2011.

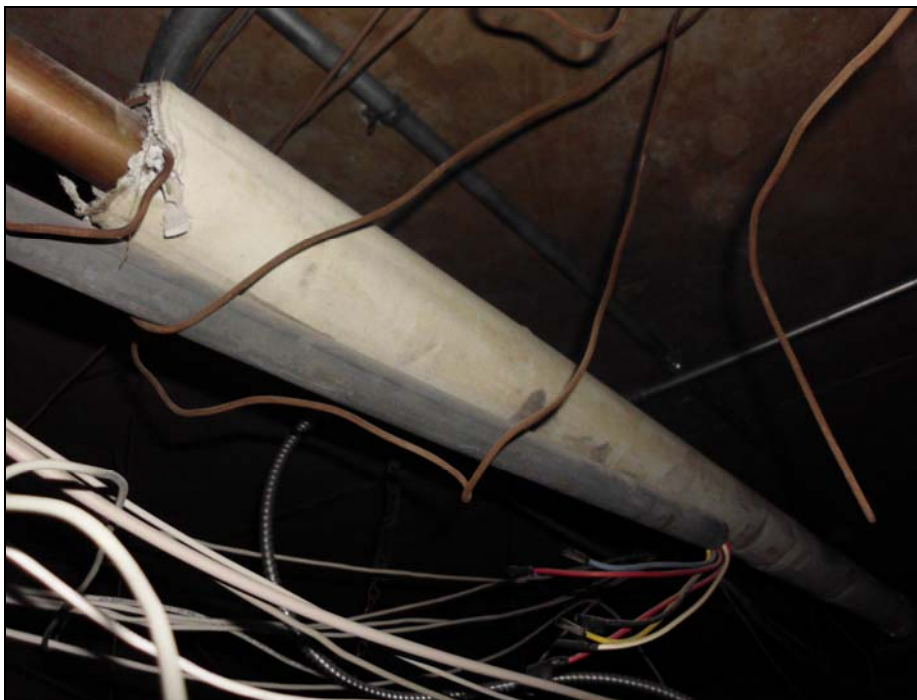
Photograph 2: Asbestos-containing AirCell pipe insulation with exposed ends in Corridor 1.C02 was removed in 2011.

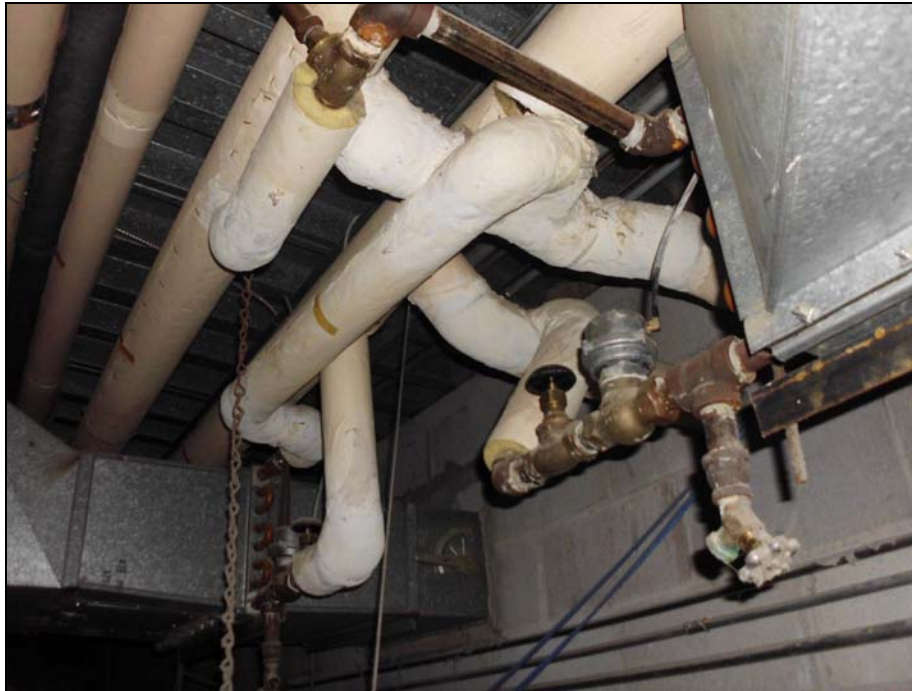
Photograph 3: Asbestos-containing pipe fittings in Corridor 1.C05. Two fittings observed to be in poor condition were repaired in 2011 (Priority 2).

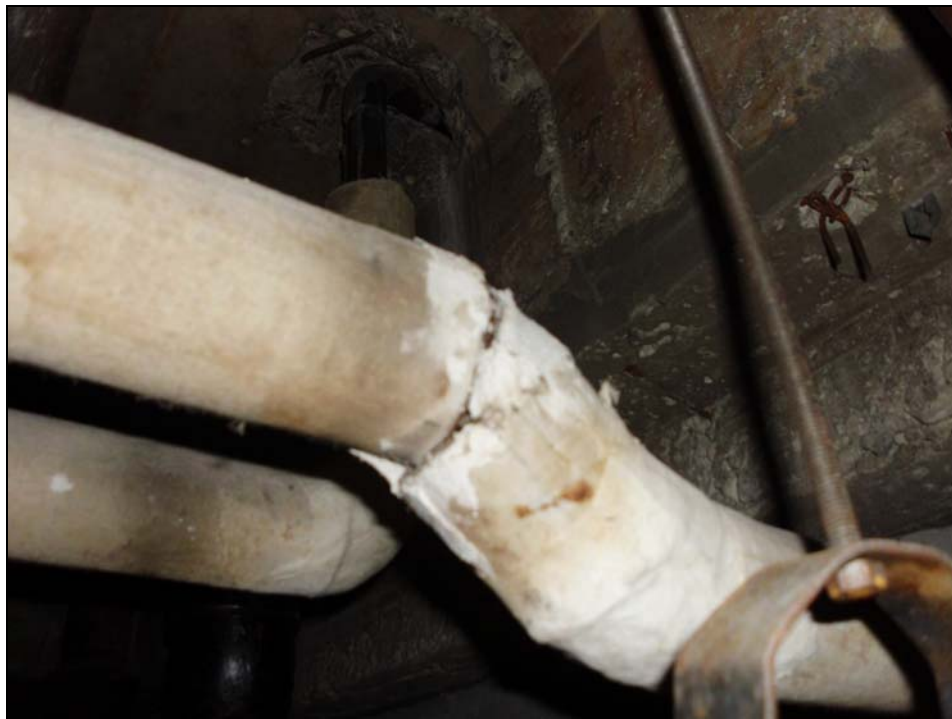
Photograph 4: Asbestos-containing pipe fittings above the suspended solid ceiling in Room 1.31 – Girls Washroom. Three fittings were observed to be in poor condition and were repaired in 2011 (Priority 2).

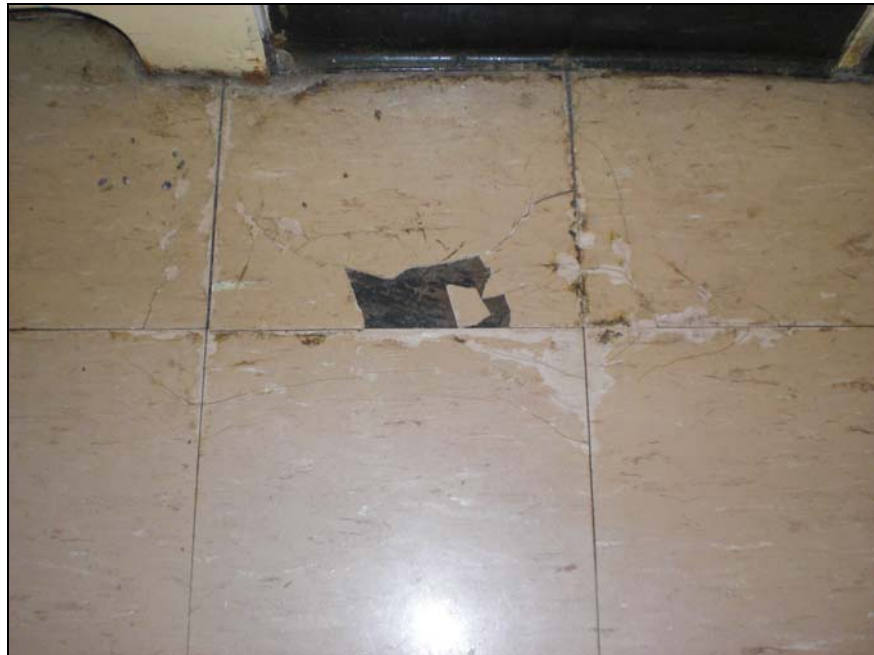
Photograph 5: Assumed asbestos-containing vinyl floor tiles in poor condition in Room 1.09 – Classroom were repaired in 2011 (Priority 2).
